# IMPACT OF THE EVA YELLOWING OF 20 COMMERCIAL MODULES ON PERFORMANCE AND DURABILITY

J. Coello, C. Lopez and F. Cornacchia

ENERTIS SOLAR

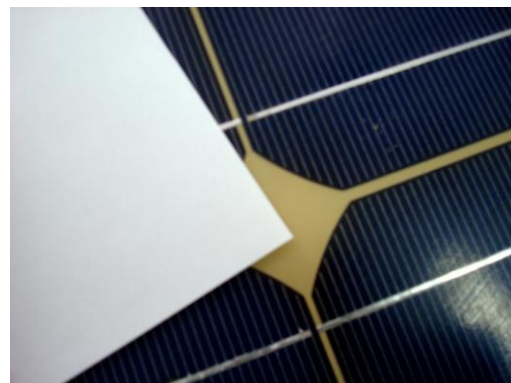
Fig.1 shows and example of discoloured module. White paper was included to make comparison of colour easier.

**Figure 1:** Module from Manufacturer A with discoloration.

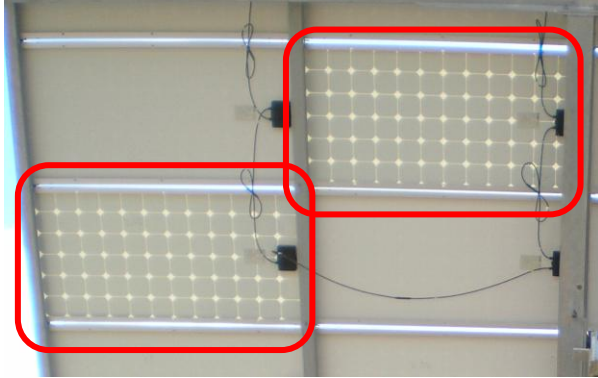
An important detail is that modules from manufacturer A were constructed with different back-sheet as Fig. 2 shows. Back-sheet of discoloured modules is brighter and more translucent than typical TPT foil.

**Figure 2:** Back-sheet of modules from Manufacturer A. Marked modules presented discoloration in laminate.

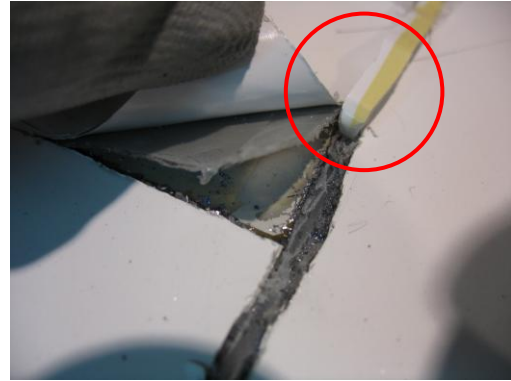
During adhesion strength test on modules from Manufacturer A, we found out that cause of discoloration is not EVA photodegradation but back-sheet photodegradation.

This situation is show in Fig. 3 where strips peeled is not discoloured where was covered by solar cell. It can be seen in Fig. 2 that these discolored modules was assembled with a different back-sheet film, probably of less quality.

**Figure 3:** Detail of back-sheet photodegradation. Strip present discoloration where was not covered by cells.

During peeling we have found out that discoloured modules from Manufacturer A, which were constructed with different back-sheet than the rest of modules, present discoloration caused by back-sheet photodegradation instead of EVA photodegradation. This discoloration is not affecting to adhesion in EVA-glass interface after one operation year. These modules should be control paying attention in any evidence of delamination.
